**Product Name:**  
GreenKonnec+ Premium MT Optical Component Coherence Reflectometer - 100mm

**Manufacturer Part Number:**  
OCCR-PREMIUM-MT

# Detect Fiber micro crack

**[OCCR]** | Optical Component Coherence Reflectometer

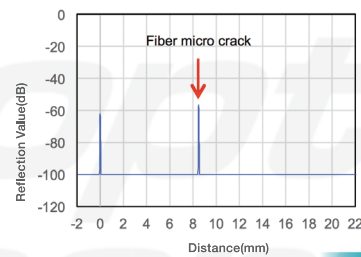
Fig.3 is a waveform of optical connector with a fiber micro crack measured by OCCR. Approx. 60dB reflection point is detected at the point of approx. 8mm.

|| Measurement waveform of OCCR

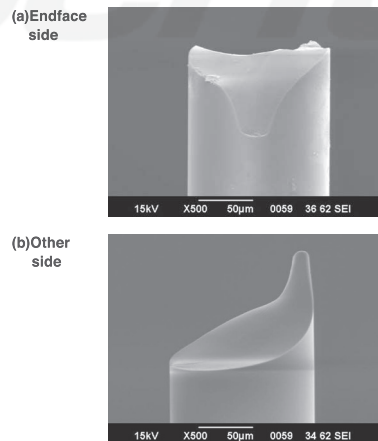
Fig.4 shows a SEM images of removed fiber micro crack from the optical connector.

There are two sides on one fiber micro crack. One is (a), and the other one is (b). It is predicted that this fiber micro crack is occurred from bending stress by analyzing these cross sections.

|| SEM images of Fiber micro crack
